RE: Response to Peer Review Comments on the Revised Addendum to Cultural Resources Assessment for the Foothill Parkway Westerly Extension Project, City of Corona, Riverside County, California

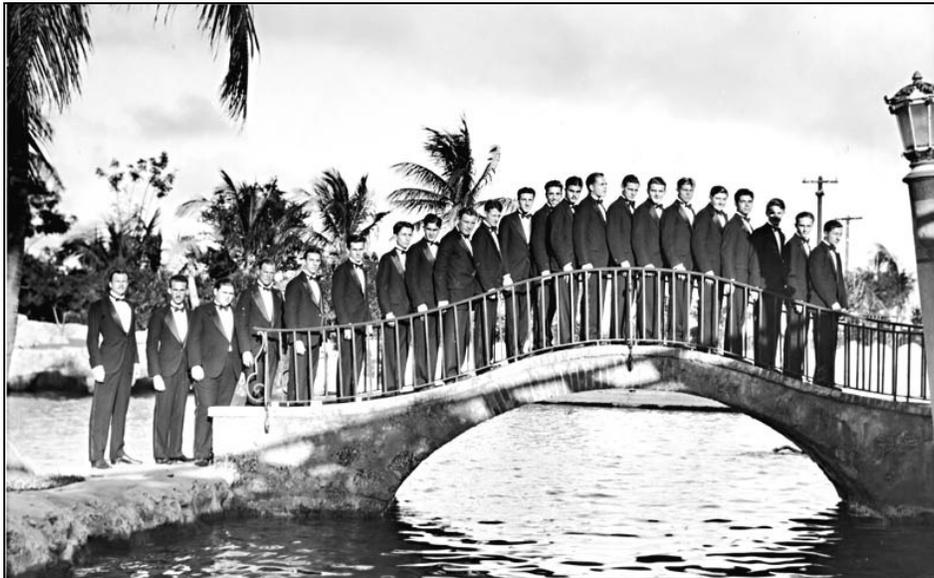
Photograph 1. Stone footbridge at Venetian Pool, Coral Gables, Florida, depicting University of Miami, Men’s Glee Club (1928–1929). Listed in the National Register of Historic Places.

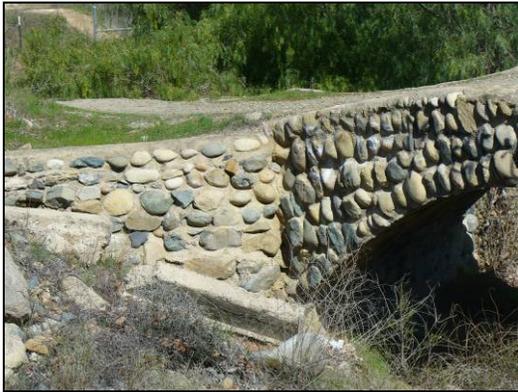
Photograph 2. View of wing wall (left side) and side of bridge. Note careful arrangement of vossior stones lining arch ring, and nearly even courses of stone comprising spandrel (11 February 2008, SWCA Environmental Consultants).

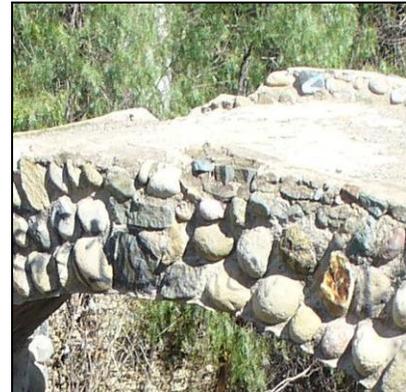
For a property to be eligible for listing in the National Register of Historic Places under Criterion C (or California Register Criterion 3), National Park Service guidance asserts that “a property important for illustrating a particular architectural style or construction technique must retain *most of the physical features that constitute that style or technique,*” in “How to Apply the National Register Criteria for Evaluation” under “VIII. How to Evaluate The Integrity of a Property.” The footbridge plainly retains most of the physical features that constitute its unique arroyo stone and concrete construction. Only a few cobble stones from the hundreds that make up the bridge and its abutments have been removed or dislodged over time.

Photograph 3. View northwest of very few missing stones at low parapet. Note uneven parapet wall at upper left of center (11 February 2008, SWCA Environmental Consultants).

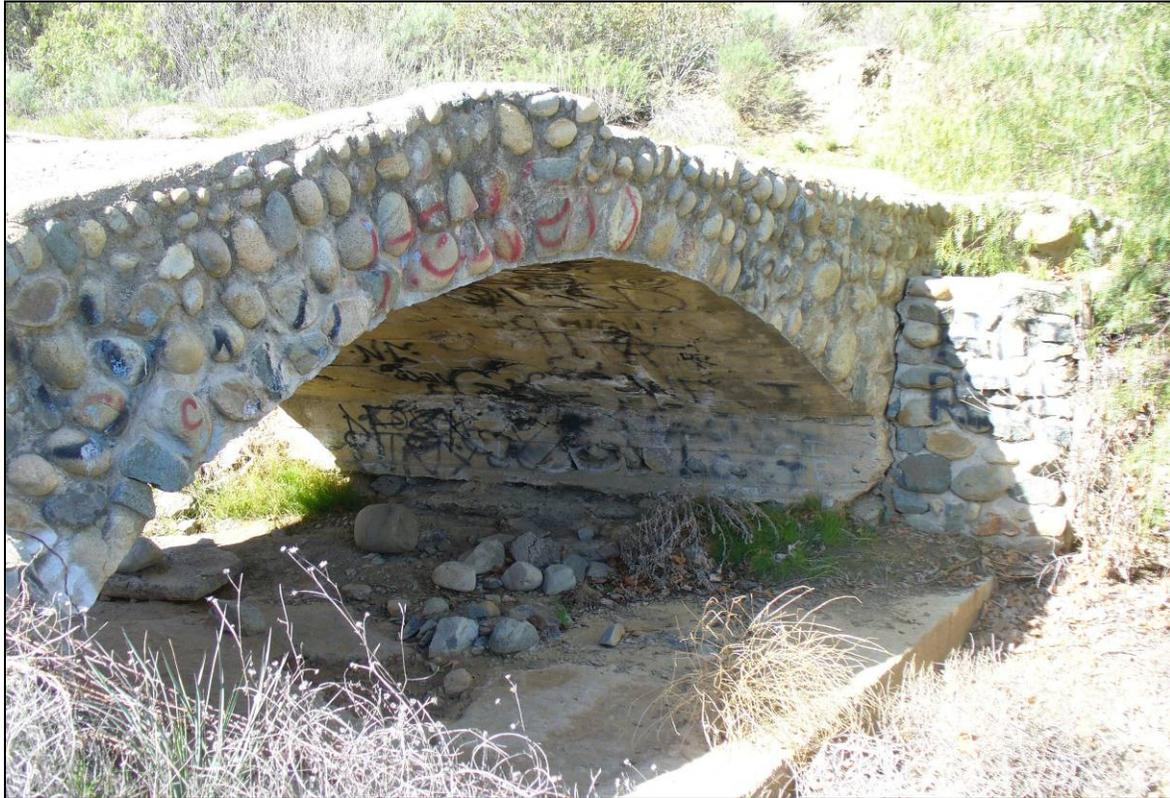
Photograph 4. Overall detail of footbridge, view northeast. Note impressions of board-formed concrete beneath bridge. Scale and proportion of the bridge were masterfully manipulated by the gentle arched slope of the deck and use of diminishing stone sizes from the arch to the parapet or railing. Note the subtle circular arrangement of stones at the crest of the arch, punctuating the gentle geometry of the larger form (11 February 2008, SWCA Environmental Consultants).
