RE: Revised Addendum to Cultural Resources Assessment for the Foothill Parkway Westerly Extension Project, City of Corona, Riverside County, California

State of California — The Resources Agency
 DEPARTMENT OF PARKS AND RECREATION
PRIMARY RECORD

BUILDING, STRUCTURE, AND OBJECT RECORD

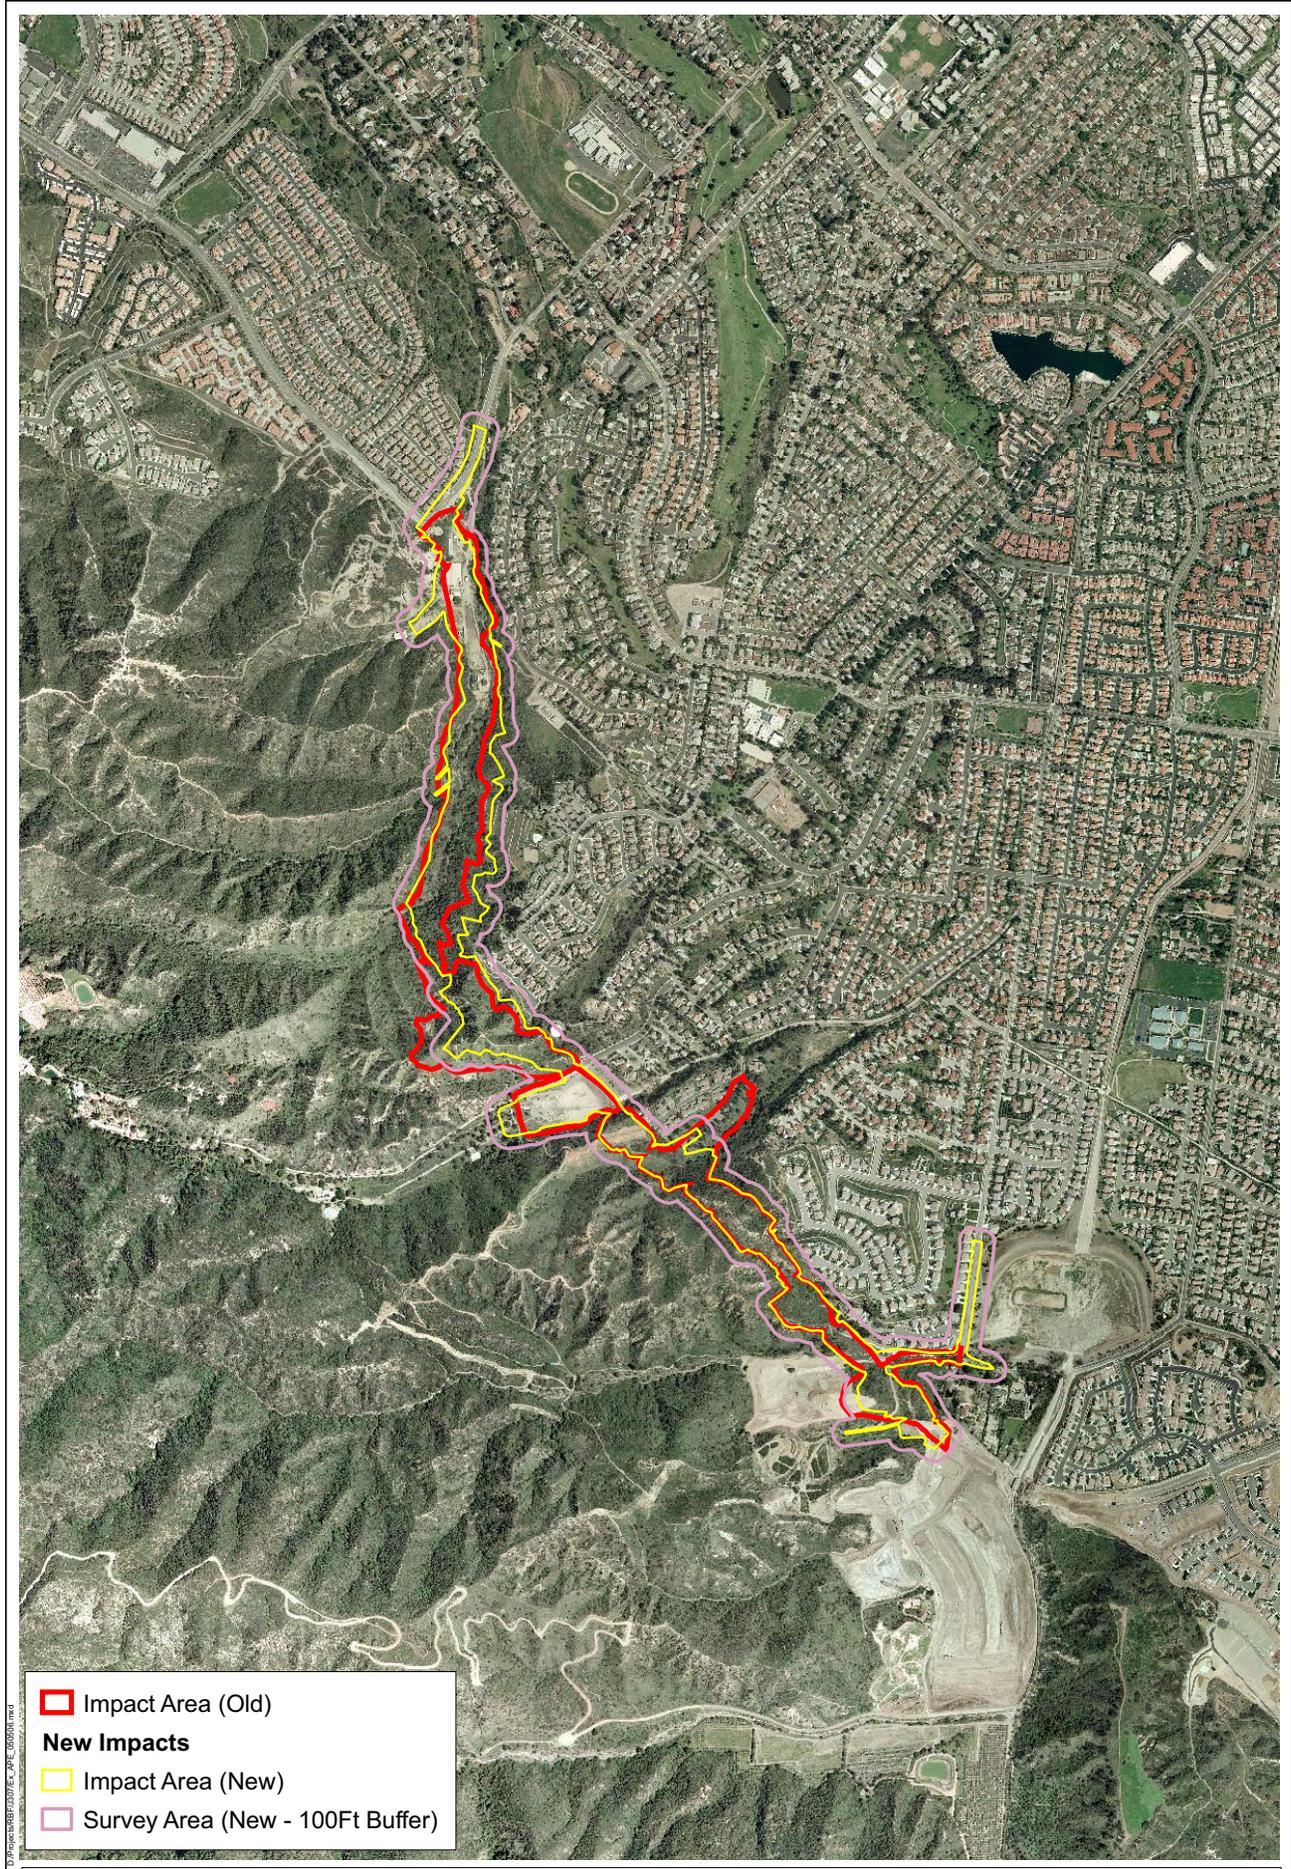
Area of Potential Effects (Old/New)

Impact Area (Old)
New Impacts
 Impact Area (New)
 Survey Area (New - 100Ft Buffer)

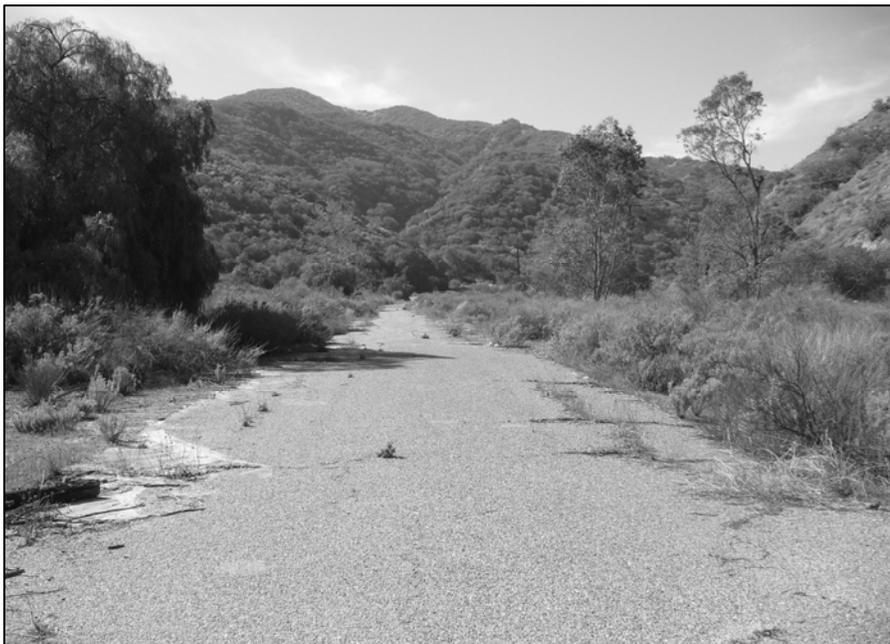
P5b. Description of Photo: (View, date, accession #) Former runway- view north, February 11, 2008, Photograph #051

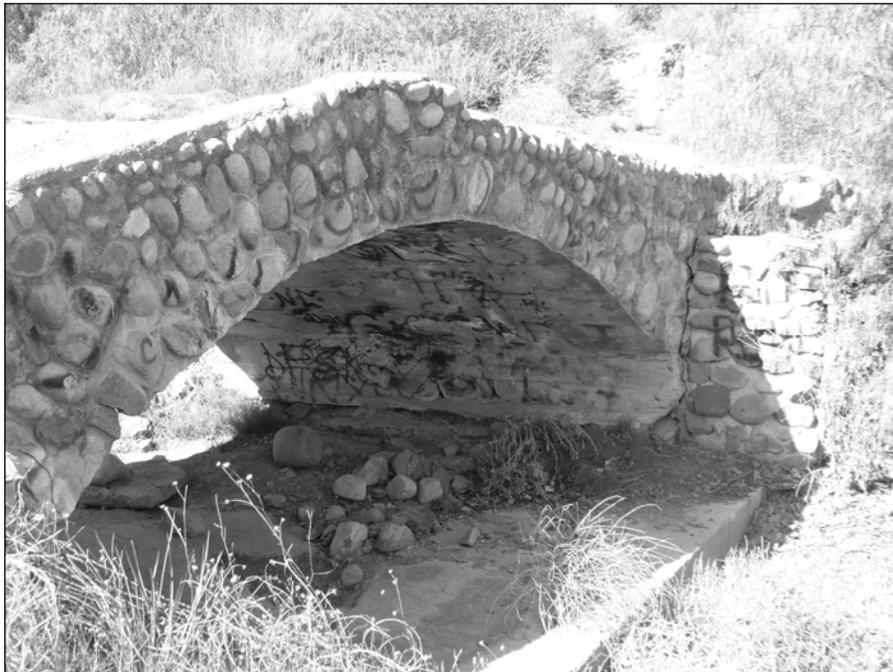
Photo 2: Arroyo stone footbridge-view northeast, February 11, 2008, Photograph #077

Other than the unreinforced masonry footbridge, none of the other remaining features retain requisite integrity to be considered for California Register eligibility. The footbridge retains integrity of its location, the connection to its immediate original setting, its materials have not been compromised, the archaic unreinforced masonry workmanship remains, its design has not been altered, and its feeling and overall association have been retained despite alterations to other features on the subject property. Because of these factors, the footbridge is eligible for listing in the California Register as a separate property under Criterion 3, because it "embodies the distinctive characteristics of a type..." and "method of construction" (archaic unreinforced masonry arch in arroyo stone) and "possesses high artistic values." The bridge expresses unity of materials, balance of design and proportion, ideal scale and distinctive character. It is an exceptional example of an increasingly rare type of resource, the unreinforced masonry bridge.

The arroyo stone footbridge is an “historical resource” under CEQA and should be avoided. Demolition of the footbridge would constitute material impairment under CEQA. SWCA recommends that project plans be revised to exclude direct or indirect impacts to the footbridge to avoid a finding of a significant impact on the environment.

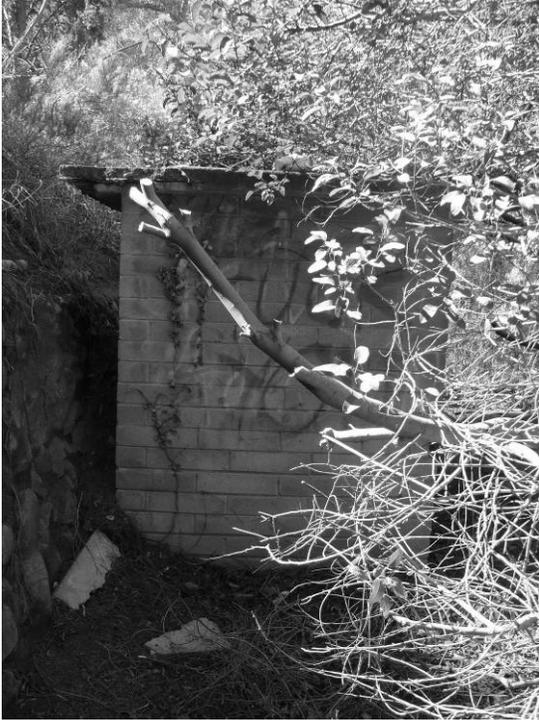
The shed is made of concrete blocks that measure 15.5 x 5.5 x 3.625 inches. The roof is a flat slab of concrete 5.5 inches thick that extends 11 inches beyond the wall around the perimeter. The structure has a pipe hole in the upper back wall measuring eight inches in diameter. The exact function of this shed is unknown.

P5b. Description of Photo: (View, date, accession #)
View of the shed, Feb 11 2006 Field Visit 014

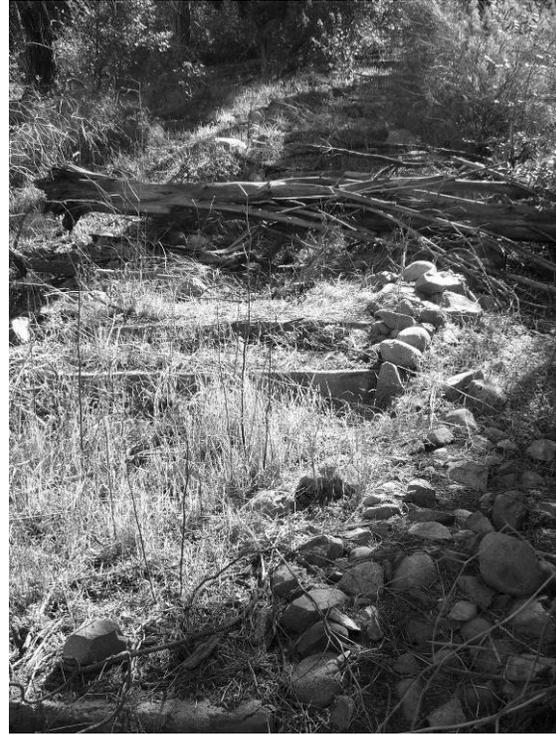
This feature was labeled as "The Stairway to Heaven," since a local informant suggested it represented a pathway to a shrine. The stairway starts at the bottom of the slope just behind and above the pool feature and leads to a small flat bench about 50 meters upslope. Along the length of the stairway are steps made of stone cobbles set in concrete and situated at various intervals up slope. Each step is about 70 inches long and some that were partially exposed are about seven inches wide. A row of cobbles, 16 to 20 inches wide, is found lining the edge of the stairway. There are cypress (or cedar) trees flanking each side the stairway at intervals up slope. Several large pine trees are located just east of the stairway. At a point near the top of the stairway there are two 4 x 4 inch posts with bracing on each side of the path suggesting that a gate once occupied the gap between the posts.

P5b. Description of Photo: (View, date, accession #)
View of the "Stairway to Heaven", Feb 11 2006 Field Visit 026

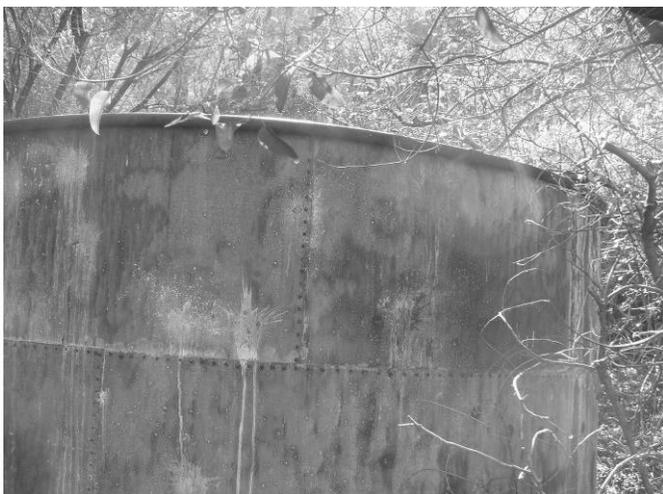
A small metal water tank is located east of the stairway and is seated on a terrace cut into the slope with the front portion resting on a 6 x 6 inch wooden beam. The tank is made of galvanized sheet metal with riveted joints. The top is open top and it measures 108 inches (9 feet) in diameter and is 42 inches tall.

P5b. Description of Photo: (View, date, accession #)
View of the small tank, Feb 11 2006 Field Visit 031

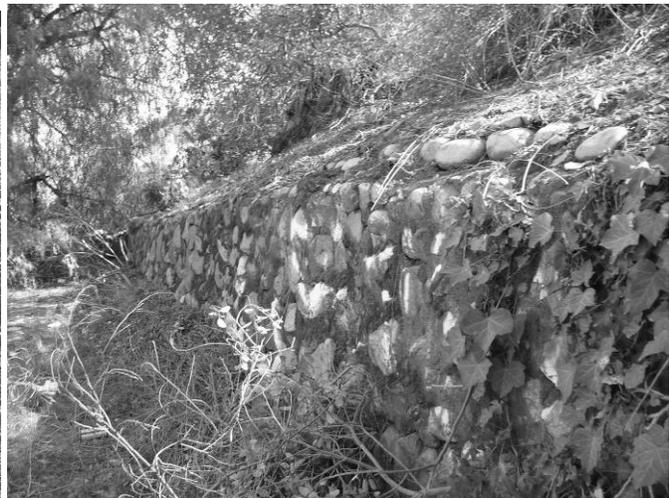
Immediately behind the building is a retaining wall that varies in height and reaches about 58 inches in height behind the masonry shed. From the masonry shed the wall runs eastward behind the house foundations for a length of about 91 feet. A small rectangular recess was set into the retaining wall and measures 72 inches wide, 36 inches deep, and 58 inches high. The ceiling or roof of the recess is concrete reinforced with steel rods and is 5.5 inches thick. All of these retaining walls are constructed of locally procured cobbles set in concrete. Another wall is located about 20 feet upslope from the main wall and runs eastward an undetermined distance.

P5b. Description of Photo: (View, date, accession #)
View of the retaining walls, Feb 11 2006 Field Visit 013
